Mobile Pentium® II Processor Specification Update

Release Date: August 1999

Order Number: 243887-013

The Mobile Pentium® II processor or the Intel® Pentium® II Processor Mobile Module may contain design defects or errors known as errata which may cause the product to deviate from published specifications. Current characterized errata are documented in this Specification Update.

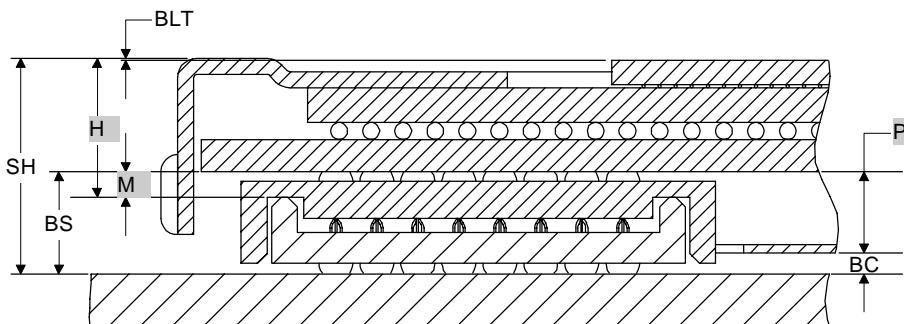
Figure 5.6. Cross Sectional View with Vertical Dimensions

B1. Misabeled Vertical Dimension Parameters

Figure 5.6 in the *Mobile Pentium® II Processor at 233 MHz, 266 MHz, and 300 MHz* datasheet should be replaced by the following figure:

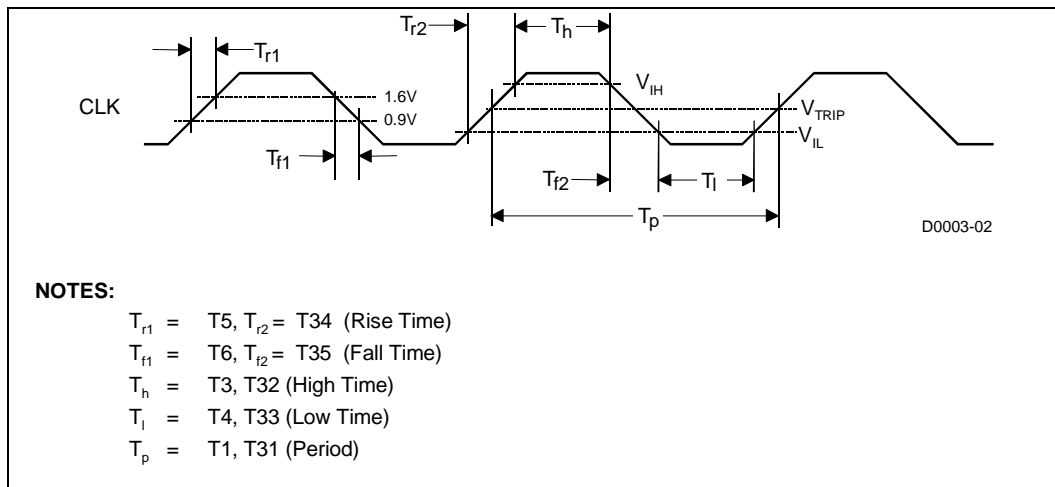
Figure 3.3 Generic Clock Waveform

B14. Generic Clock Waveform Figure

Figure 3.3 in *Mobile Pentium® II Processor in Mini-Cartridge Package at 366 MHz, 333 MHz, 300PE MHz, and 266PE MHz* datasheet (Order Number 245108), and the *Mobile Pentium® II Processor in BGA Package at 366 MHz, 333 MHz, 300PE MHz, and 266PE MHz* datasheet (Order Number 245106) has been updated. The following figure is to replace the ones in the above documents.
